**Flood Control Project Maintenance
Levee Inspections**
LMA District Cover Sheet
Spring 2018 Levee Inspection Results

Reclamation District No. 0003 Grand Island

Spring 2018 Levee Inspection Results

| Waterway | | | Bank | Unit Miles |
|--|---|---|---|---|
| Unit No. 01 Left Bank Steamboat Slough | | | Left | 10.95 |

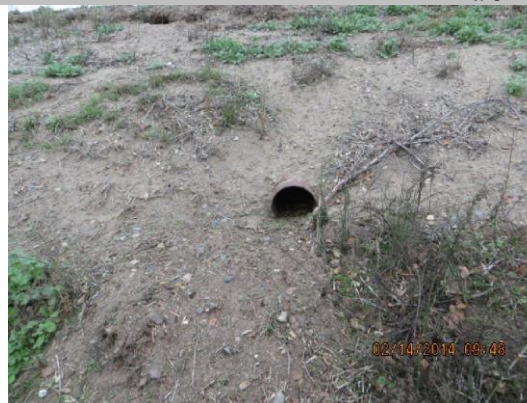
Photo 1 of 2 : UCIP_SP_2018_41583_55234.jpg

| FS_ID:41583 DS_ID:22134 EP_NO: N/A Repair Type: Non-Urgent Crossing Status: Found UCIP Comments: Pipe open on LS slope. Appears abandoned and if so should be done so properly. FIELD_STRUCT_DESC: *ABANDONED* 10-inch steel irrigation pipe through the levee, invert elevation 6.6 feet below the crown. 36-inch concrete standpipe visible 30 feet upstream from the crossing on the landside (LS) toe. Pipe open on both ends. [Additional Reference(s): DWR Levee Log, 1993. USACE Sacramento O&M Manual 104, February 1960, (RM 26.06)]. FS Date: 8/27/2014 | | | | | |

Open pipe visible on LS slope.

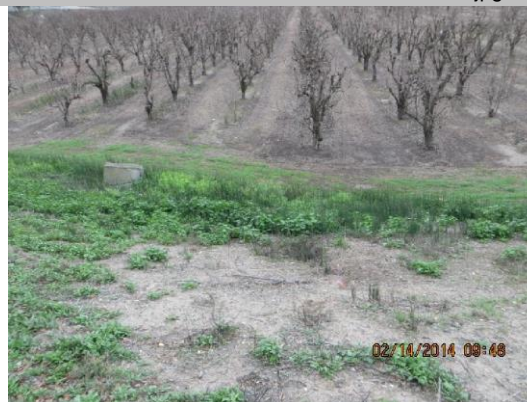
Photo 2 of 2 : UCIP_SP_2018_41583_55233.jpg

Concrete standpipe visible on LS slope

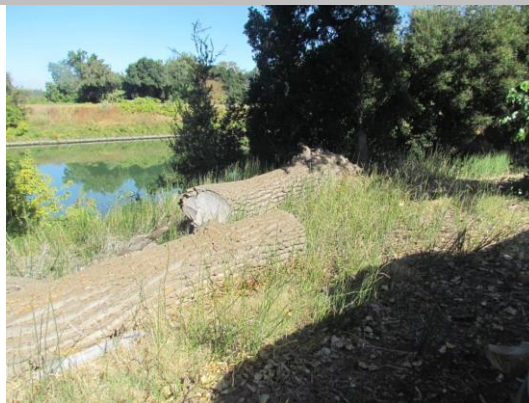
Photo 1 of 4 : SP_2018_RD0003_24_19_20180305_00021.jpg

Looking north at tree branches on waterward slope. (Fall 2016)

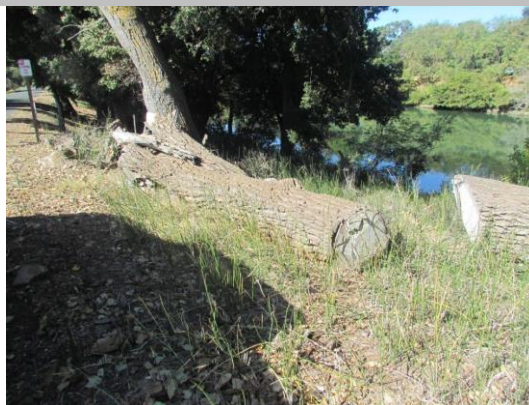
Photo 2 of 4 : SP_2018_RD0003_24_19_20180305_00022.jpg

Looking west at tree branch on waterward shoulder and slope. (Fall 2016)

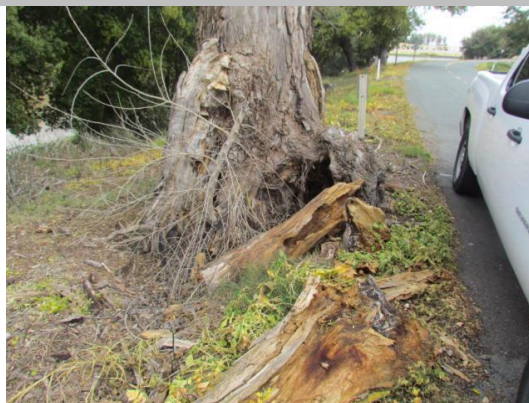
Photo 1 of 3 : SP_2018_RD0003_24_2_20180305_00003.jpg

| Hole (8ft x 2.5ft x 5ft) next to a large tree on waterward shoulder. | | | | | | |

Looking east at hole at the base of an oak tree on the waterward shoulder. (2016)

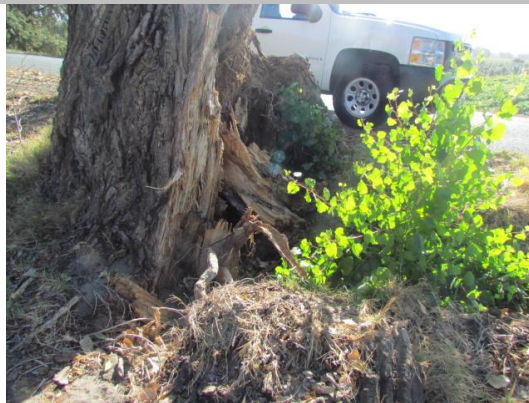
Photo 2 of 3 : SP_2018_RD0003_24_2_20180305_00004.jpg

Looking at a hole next to oak tree on waterward shoulder. (2015)

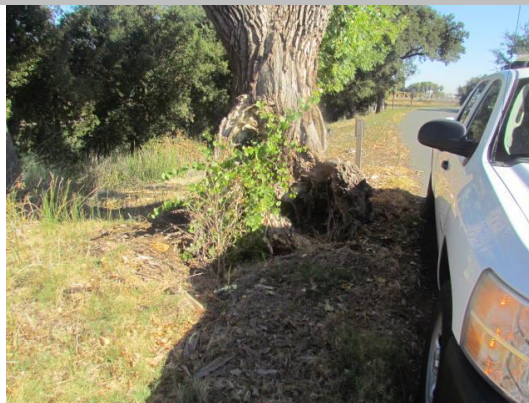
Photo 3 of 3 : SP_2018_RD0003_24_2_20180305_00005.jpg

| Hole (8ft x 2.5ft x 5ft) next to a large tree on waterward shoulder. | | | | | | |

Looking east at hole at base of tree on waterward shoulder. (2014)

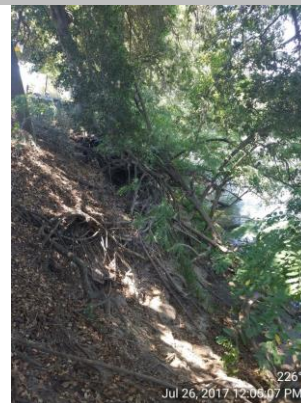
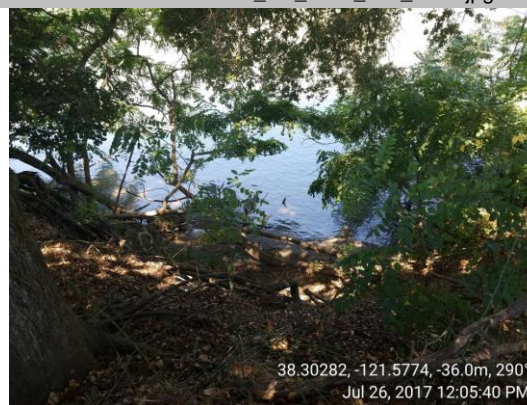
| Notes: trees undercut by erosion | | | | | |

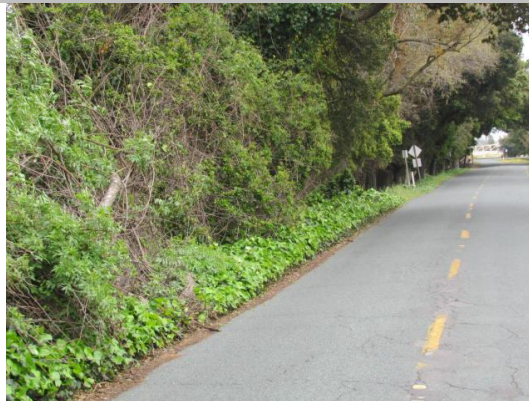
Photo 1 of 2 : SP_2018_RD0003_24_6_20180305_00007.jpg

| Dense landscaping on waterward shoulder and slope. | | | | | |

Looking northeast at dense landscaping on waterward shoulder.

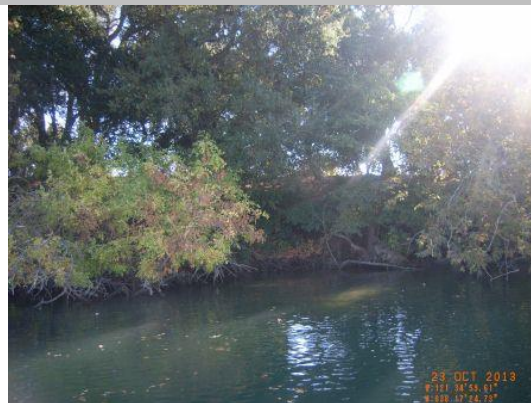
Photo 1 of 2 : SP_2018_RD0003_24_1_20180305_00001.jpg

| 2008 - Area closed sign on bank. Newly fallen trees at both ends and pop outs along the bank. 2010 - Site extended downstream. 2011 - New erosion at the toe. More trees popouts. 2013 - Short vertical sections observed at the downstream end. 2015: New erosion at toe. [2015 Site ID: STM 24-8 L] | | | | | |

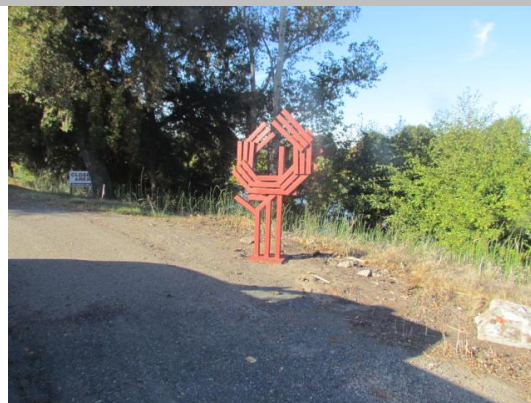
Photo 1 of 1 : SP_2018_RD0003_24_132_20180305_00088.jpg

| Unauthorized sign on waterward shoulder. | | | | | |

Looking southwest at sign on waterward shoulder.

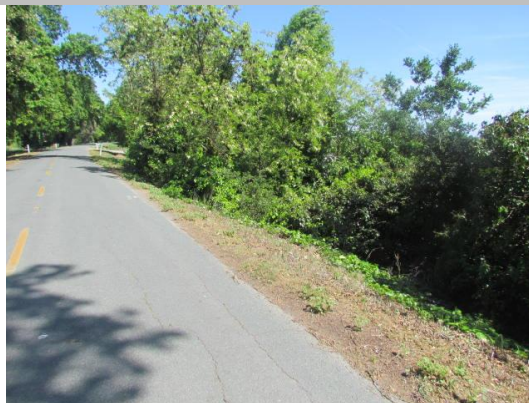
Photo 1 of 2 : SP_2018_RD0003_24_12_20180305_00016.jpg

Looking northeast at dense landscape on landward slope. (Spring 2013)

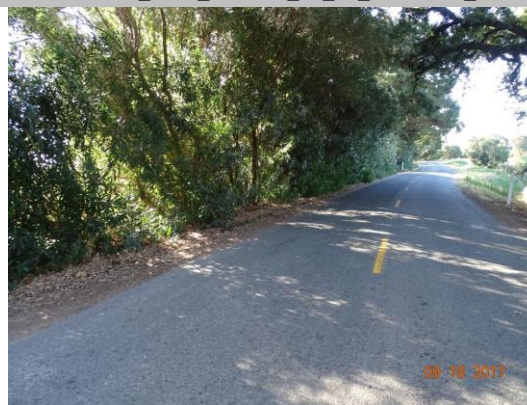
Photo 1 of 2 : SP_2018_RD0003_24_21_20180305_00026.jpg

| Landscaping has been in place for several years. | | | | | |

Looking south at landside slope.

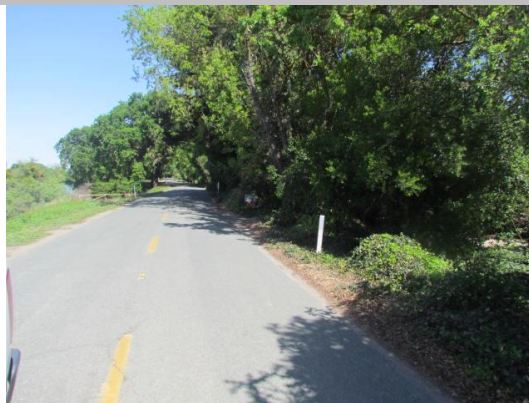
Photo 2 of 2 : SP_2018_RD0003_24_21_20180305_00027.jpg

| Landscaping has been in place for several years. | | | | | | |

Looking north at dense landscaping on landward shoulder and slope.(Spring 2017)

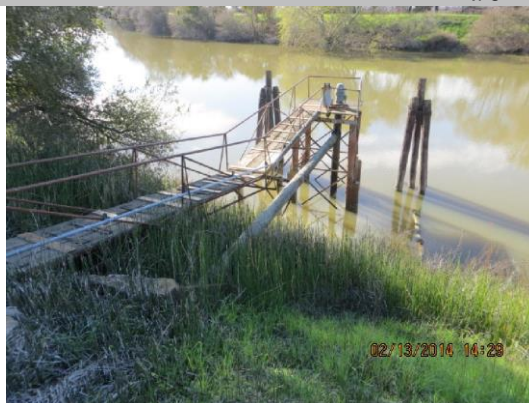
Photo 1 of 3 : UCIP_SP_2018_31287_57298.jpg

Walkway to pier on WS shoulder.

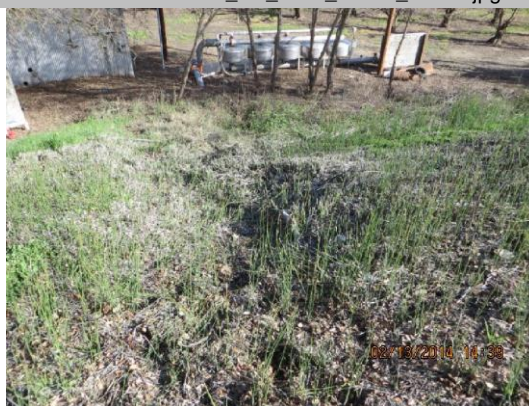
Photo 2 of 3 : UCIP_SP_2018_31287_57297.jpg

Pipe visible just off LS shoulder in vegetation.

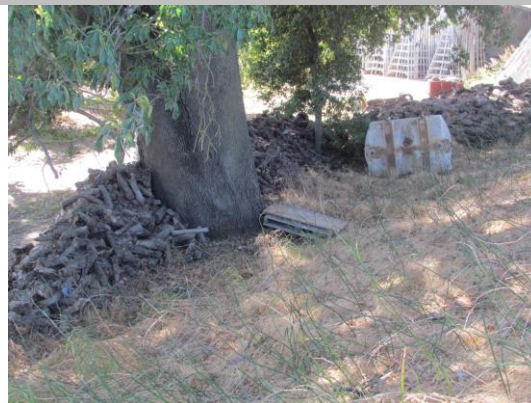
Photo 1 of 1 : SP_2018_RD0003_24_69_20180305_00057.jpg

| Landowner stockpiling firewood at landward toe. | | | | | |

Looking southeast at firewood stockpiled at landward toe.

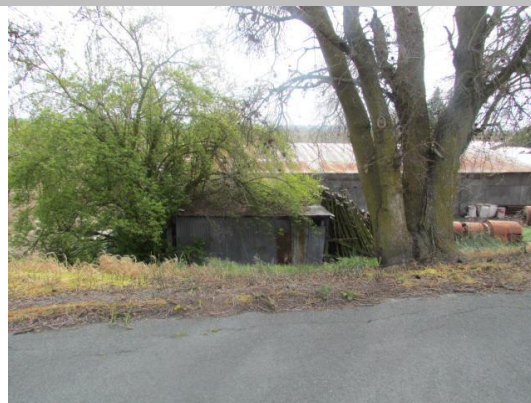
Photo 1 of 3 : SP_2018_RD0003_24_33_20180305_00032.jpg

| Equipment and large fallen tree on landward toe. | | | | | |

Looking east at tool shed and equipment on landside toe.

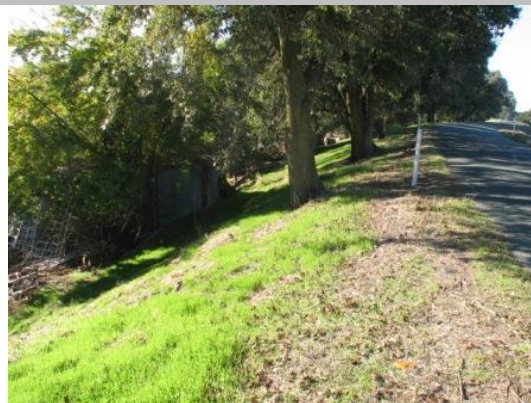
Photo 2 of 3 : SP_2018_RD0003_24_33_20180305_00033.jpg

Equipment within 10' of levee toe obstructs access and visibility.

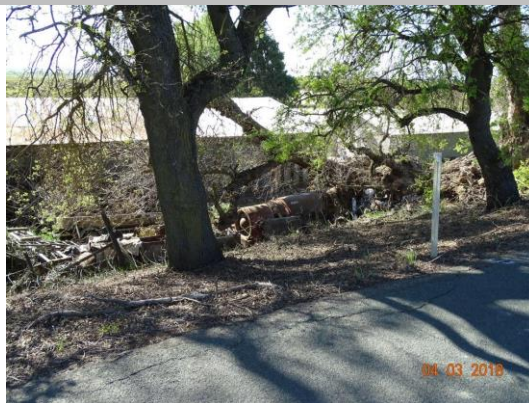
Photo 3 of 3 : SP_2018_RD0003_24_33_20180403_00169.jpg

| Equipment and large fallen tree on landward toe. | | | | | | |

Equipment and fallen tree on landside toe.

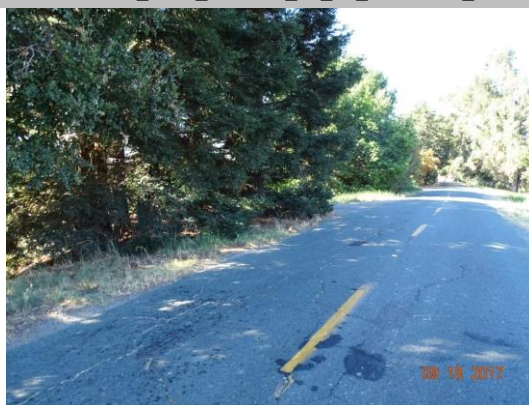
Photo 1 of 2 : SP_2018_RD0003_24_15_20180305_00018.jpg

| Large redwood trees on landward shoulder. | | | | | |

Looking southwest at landside slope.

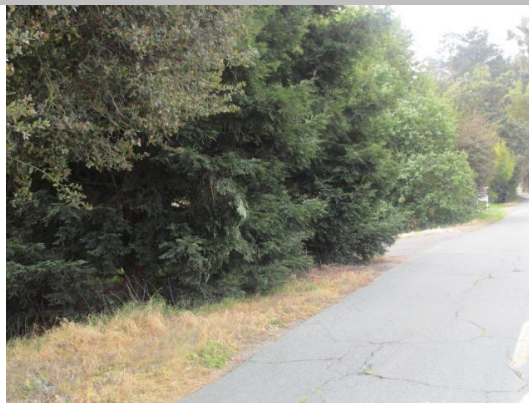
Photo 2 of 2 : SP_2018_RD0003_24_15_20180305_00019.jpg

Looking southeast at dense trees on landside shoulder and slope.
(updated Spring 2012)

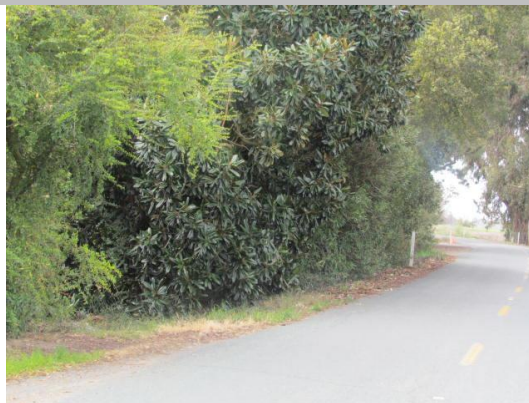
Photo 1 of 1 : SP_2018_RD0003_24_7_20180305_00009.jpg

Looking south at dense landscaping on landside shoulder and slope.

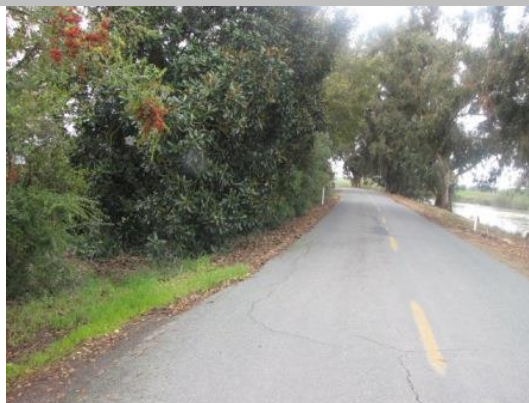
Photo 1 of 1 : SP_2018_RD0003_24_16_20180305_00020.jpg

Looking southwest at dense landscaping on landside shoulder and slope.

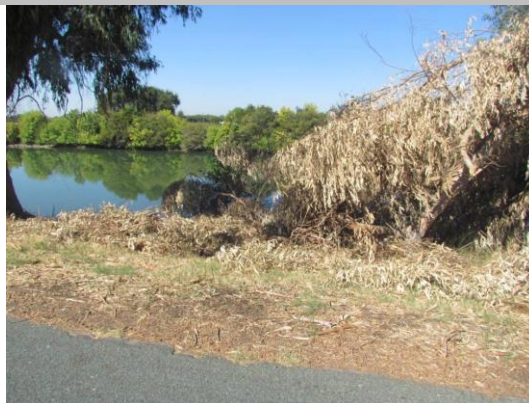
Photo 1 of 2 : SP_2018_RD0003_24_62_20180305_00051.jpg

| Broken tree branch on waterward slope. | | | | | |

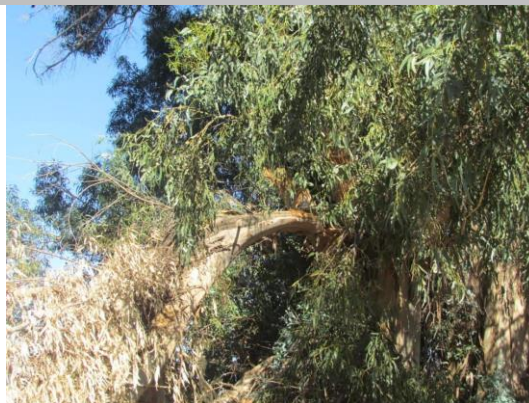
Photo 2 of 2 : SP_2018_RD0003_24_62_20180305_00052.jpg

| Broken tree branch on waterward slope. | | | | | | |

Looking southwest at broken branches on waterward slope.

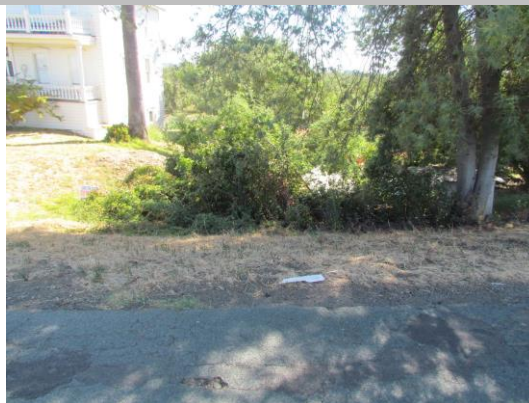
Photo 1 of 2 : SP_2018_RD0003_24_8_20180305_00010.jpg

Looking east at vegetation on landward slope. (Fall 2016)

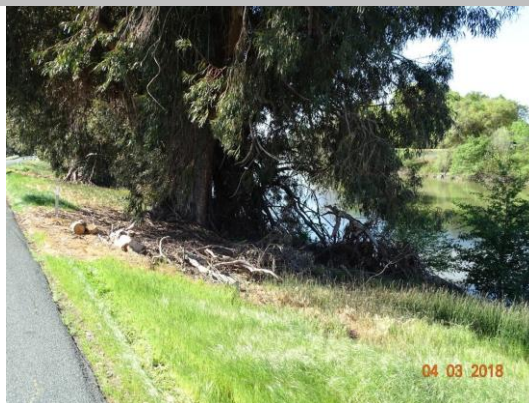
Photo 1 of 1 : SP_2018_RD0003_24_54_20180403_00170.jpg

| Cut branches on waterside slope and shoulder. | | | | | |

Cut branches on waterside slope.

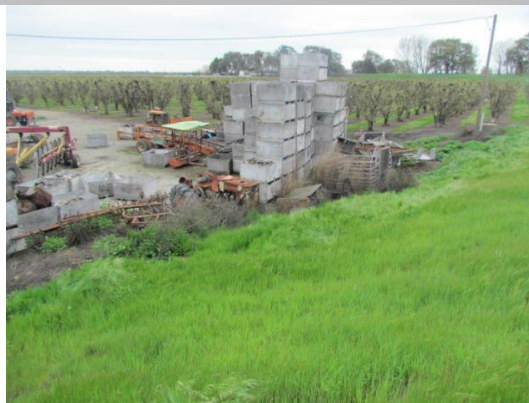
Photo 1 of 1 : SP_2018_RD0003_24_70_20180305_00058.jpg

| Old farm equipment and storage containers stored at landward toe. | | | | | |

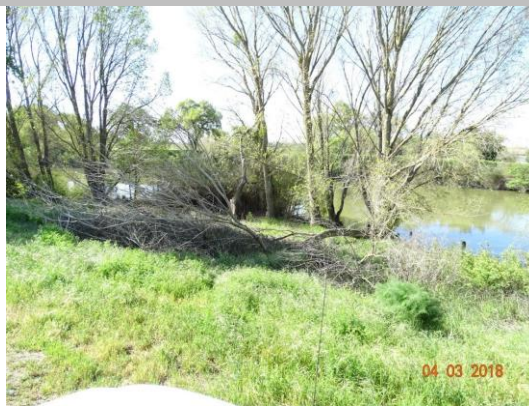
Photo 1 of 1 : SP_2018_RD0003_24_55_20180403_00171.jpg

| Fallen tree on waterside slope. | | | | | |

Fallen tree limb on waterside.

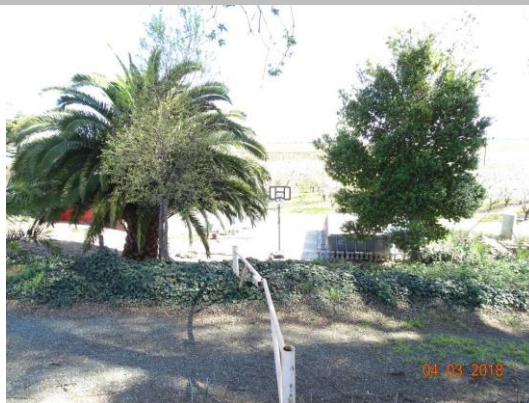
Photo 1 of 1 : SP_2018_RD0003_24_26_20180403_00172.jpg

| Landscaping has been reduced in this area, but still inhibits inspection and access. | | | | | |

Landscaping should continue to be reduced.

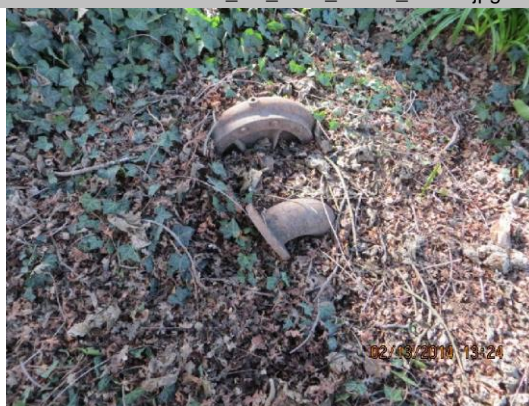
Photo 1 of 3 : UCIP_SP_2018_29569_54641.jpg

| FS_ID:29569 DS_ID:22324 EP_NO: 4346 Repair Type: Non-Urgent Crossing Status: Indicator Found UCIP Comments: Pipe is abandoned and should be verified as having been done so properly. FIELD_STRUCT_DESC: 6-inch steel irrigation discharge pipe through the levee, invert elevation 1.5 feet below the crown. Pump visible at the landside (LS) toe. (Plans for replacing existing 10-inch pipe with a new 10-inch pipe through the levee authorized under Permit No. 4346, 1963 - Hamatani Brothers). [Additional Reference(s): USACE Sacramento O&M Manual 104, February 1960, (RM 23.70)]. FS Date: 2/13/2014 | | | | | | |

Pump visible on LS toe.

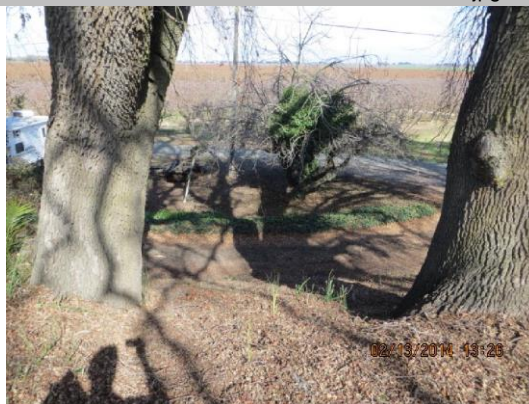
Photo 2 of 3 : UCIP_SP_2018_29569_54640.jpg

Pump visible at LS toe. Pipe alignment of old pipe goes between two large oaks on LS shoulder.

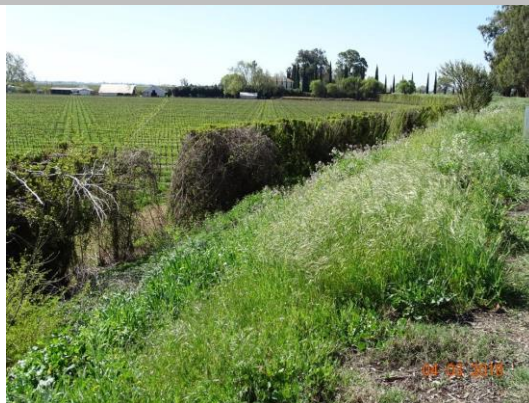
Photo 1 of 1 : SP_2018_RD0003_24_65_20180403_00174.jpg

Landside vegetation.

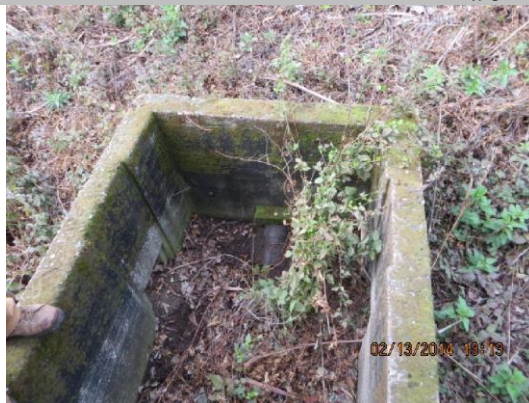
Photo 2 of 2 : UCIP_SP_2018_29567_54633.jpg

| FS_ID:29567 DS_ID:22146 EP_NO: N/A Repair Type: Non-Urgent Crossing Status: Found UCIP Comments: Need to verify proper abandonment of irrigation pipe. FIELD_STRUCT_DESC: *ABANDONED* 10-inch steel irrigation discharge pipe through the levee, invert elevation 4.2 feet below the crown. 5-foot by 7-foot concrete distribution box at the landside (LS) toe. Cannot see pipe on the waterside (WS). [Additional Reference(s): DWR Levee Log, 1993. USACE Sacramento O&M Manual 104, February 1960, (RM 23.55)]. FS Date: 2/13/2014 | | | | | | |

Pipe visible inside concrete distribution box on LS toe.

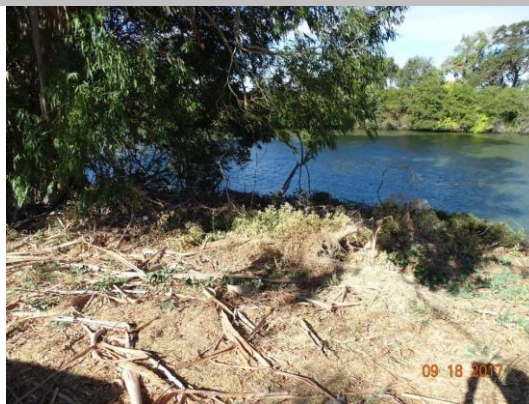
Photo 1 of 1 : SP_2018_RD0003_24_82_20180305_00074.jpg

Looking southwest at waterside slope.

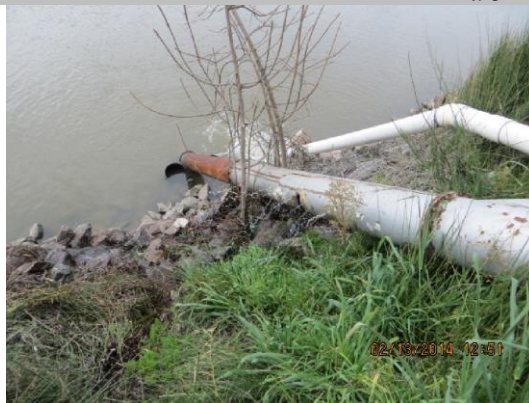
Photo 1 of 3 : UCIP_SP_2018_29563_54622.jpg

| FS_ID:29563 DS_ID:22148 EP_NO: N/A Repair Type: Non-Urgent Crossing Status: Found UCIP Comments: Pitted holes on slant pump intake may indicate internal problem. Good candidate for video inspection. FIELD_STRUCT_DESC: 14-inch steel irrigation discharge pipe though the levee, invert elevation 6.3 feet below the crown. Service pole on the landside (LS) slope. 1.5-inch electrical conduit through the levee to the pump on the waterside (WS). 36-inch concrete standpipe at the landside (LS) toe. [Additional Reference(s): DWR Levee Log, 1993, 16-inch pipe referenced. USACE Sacramento O&M Manual 104, February 1960, (RM 23.17), 16-inch pipe referenced]. FS Date: 2/13/2014 | | | | | |

Intake pipe at slantpump on WS slope.

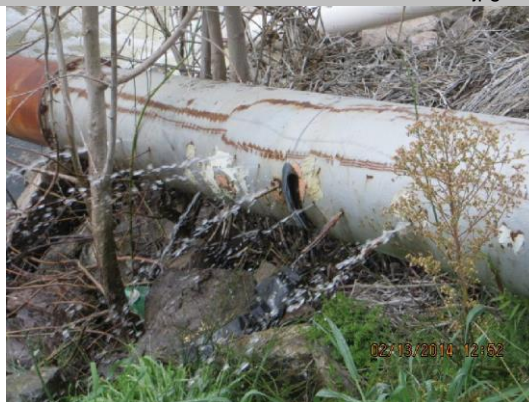
Photo 2 of 3 : UCIP_SP_2018_29563_54621.jpg

Multiple leaks in suction pipe on WS slope.

| FS_ID:29563 DS_ID:22148 EP_NO: N/A Repair Type: Non-Urgent Crossing Status: Found UCIP Comments: Pitted holes on slant pump intake may indicate internal problem. Good candidate for video inspection. FIELD_STRUCT_DESC: 14-inch steel irrigation discharge pipe though the levee, invert elevation 6.3 feet below the crown. Service pole on the landside (LS) slope. 1.5-inch electrical conduit through the levee to the pump on the waterside (WS). 36-inch concrete standpipe at the landside (LS) toe. [Additional Reference(s): DWR Levee Log, 1993, 16-inch pipe referenced. USACE Sacramento O&M Manual 104, February 1960, (RM 23.17), 16-inch pipe referenced]. FS Date: 2/13/2014 | | | | | | |

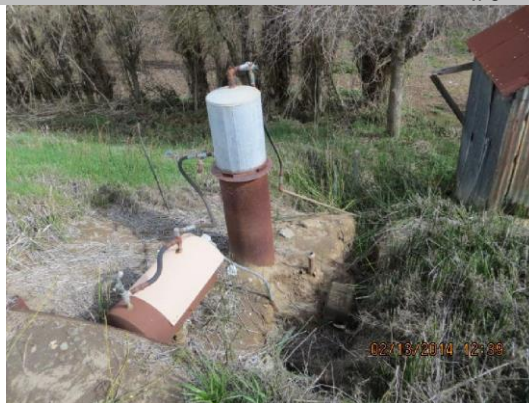
Photo 1 of 2 : UCIP_SP_2018_31327_57380.jpg

| FS_ID:31327 DS_ID:22149 EP_NO: 6870 Repair Type: Non-Urgent Crossing Status: Found UCIP Comments: Erosion on LS slope between pumphouse and tank. FIELD_STRUCT_DESC: 1 of 3: 18-inch steel irrigation discharge pipe through the levee, invert elevation 5.5 feet below the crown. Primer pump in a pump house on the landside (LS) slope. Tank and filler pipes on the LS slope. (Plans to retain a pump house, a pressure tank, two buried metal tanks, and a pipeline authorized under Permit No. 6870, 1970 - H. P. Garin Jr, et al.). [Additional Reference(s): DWR Levee Log, 1993. USACE Sacramento O&M Manual 104, February 1960, (RM 23.03)]. FS Date: 2/13/2014 | | | | | |

Pumphouse , tank, and filler pipes visible on LS slope. (note erosion between tank and pumphouse.

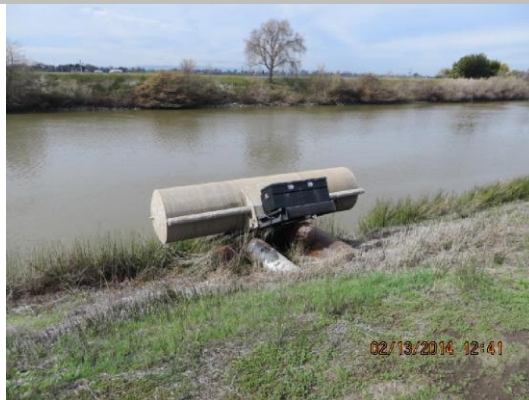
Photo 2 of 2 : UCIP_SP_2018_31327_57379.jpg

Pipe with fish screen visible on WS slope.

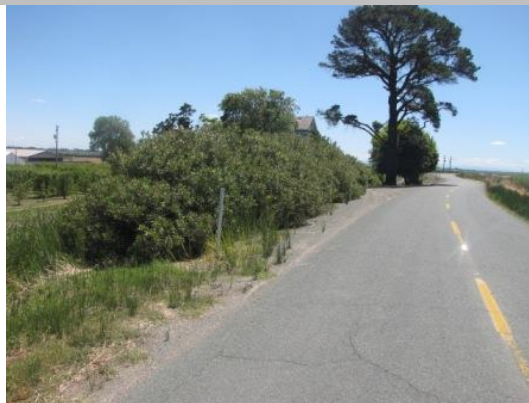
Photo 1 of 1 : SP_2018_RD0003_24_20_20180305_00025.jpg

| Oleander on landside shoulder. | | | | | |

Looking south at dense veg. on landside slope.

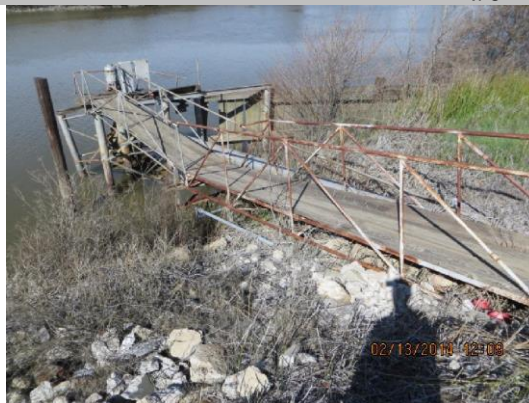
Photo 1 of 3 : UCIP_SP_2018_29547_54611.jpg

| FS_ID:29547 DS_ID:22151 EP_NO: 1113 Repair Type: Non-Urgent Crossing Status: Found UCIP Comments: Pump pier is damaged and falling into the water. FIELD_STRUCT_DESC: 12-inch steel irrigation discharge pipe through the levee, invert elevation 4 feet below the crown. Vertical pump on a pile structure in the stream. Walkway from the waterside (WS) berm to the pump. 1.5-inch electrical conduit and 2.5-inch filler pipe at the same location. 36-inch concrete standpipe on the landside (LS) toe. (Plans for the installation of a 12-inch irrigation pipe through the levee authorized under Permit No. 1113, 1946 - Elsie Goldman Dixon). [Additional Reference(s): DWR Levee Log, 1993. USACE Sacramento O&M Manual 104, February 1960, (RM 22.85)]. FS Date: 2/13/2014 | | | | | |

Walkway to pump on pier at WS slope.

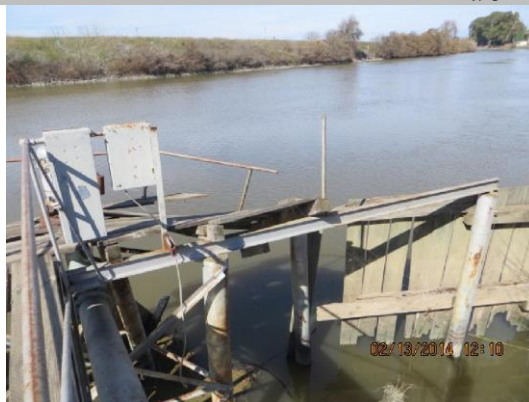
Photo 2 of 3 : UCIP_SP_2018_29547_54610.jpg

Damaged pump platform at WS toe.

| UCIP Comments: Pump pier is damaged and falling into the water. | | | | | | |

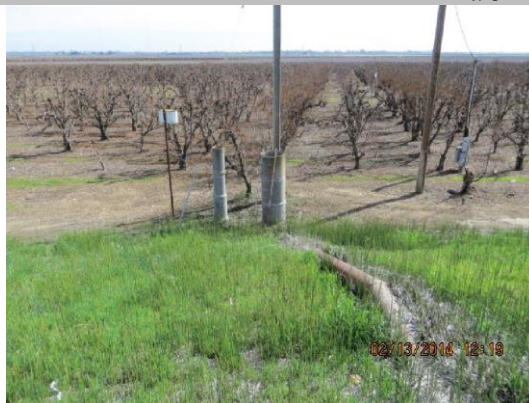
Photo 3 of 3 : UCIP_SP_2018_29547_54609.jpg

Concrete standpipe and pipe visible on LS toe.

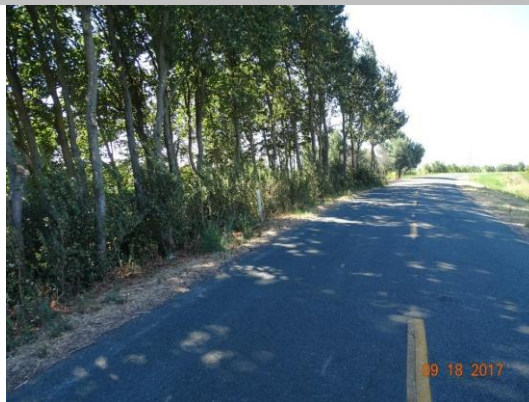
Photo 1 of 3 : SP_2018_RD0003_24_9_20180305_00012.jpg

Looking south at landside slope.

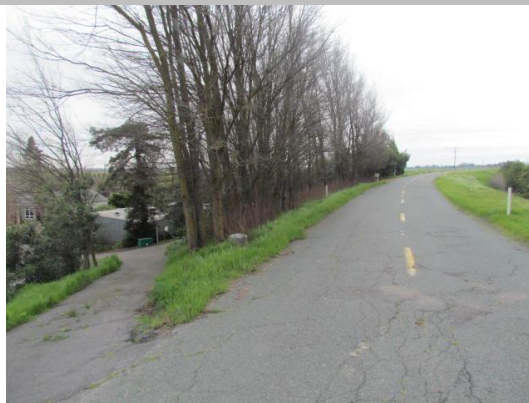
Photo 2 of 3 : SP_2018_RD0003_24_9_20180305_00013.jpg

Looking south at trees on landward shoulder and slope (Spring 2016).

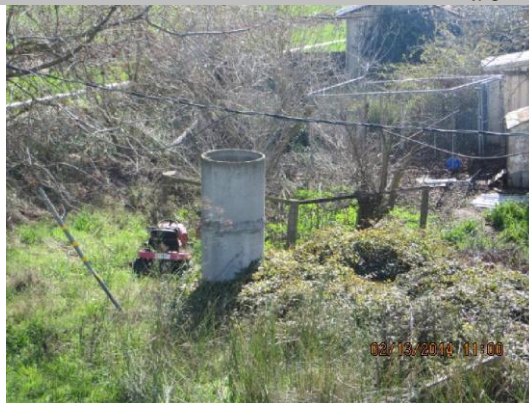
Photo 1 of 2 : UCIP_SP_2018_31583_57841.jpg

FS_ID:31583
DS_ID:22160
EP_NO: 7948
Repair Type: Non-Urgent
Crossing Status: Found
UCIP Comments: Siphon breaker missing from LS shoulder.
FIELD_STRUCT_DESC: 14-inch coated steel irrigation discharge pipe through the levee, 4.5 feet below the crown. Pipe measures 12 inches on the slopes. Slant pump and platform on the waterside (WS) slope. Siphon breaker on the landside (LS) shoulder. 36-inch concrete standpipe off the LS toe. 1.5-inch galvanized iron electrical conduit at the same location. (Plans to replace pump and pipe through the levee authorized under Permit No. 7948, 1972 - Carl E. van Loben Sels).
[Additional Reference(s): DWR Levee Log, 1993. USACE Sacramento O&M Manual 104, February 1960, (RM 21.97), referenced as invert elevation 4.2 feet below the crown].
FS Date: 2/13/2014

36-inch concrete standpipe off LS toe.

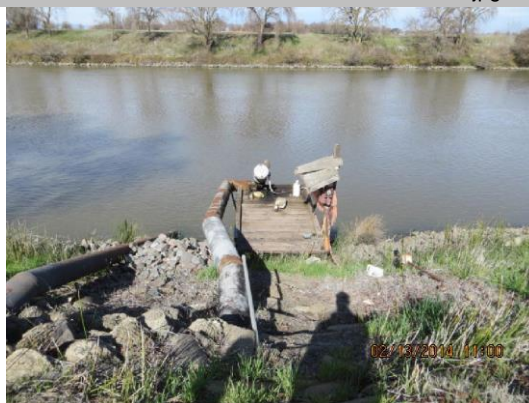
Photo 2 of 2 : UCIP_SP_2018_31583_57840.jpg

Pipe visible on WS slope with pump on pier and electrical conduit.

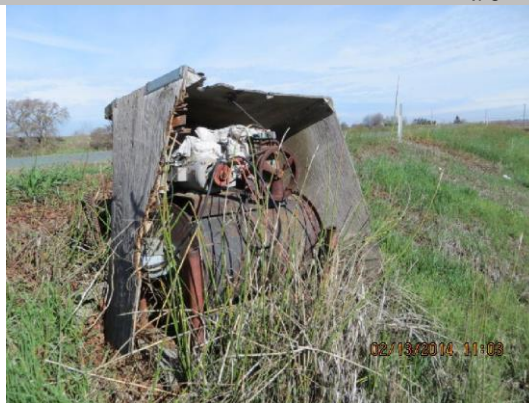
Photo 1 of 3 : UCIP_SP_2018_31584_57843.jpg

| FS_ID:31584 DS_ID:22158 EP_NO: N/A Repair Type: Non-Urgent Crossing Status: Found UCIP Comments: Appears abandoned and if so should be done so properly. FIELD_STRUCT_DESC: 12-inch steel irrigation siphon through the levee, invert elevation 2.7 feet below the crown. Pump and tank visible in a box on the landside (LS) shoulder. Electrical panel on the LS slope with a concrete standpipe at the LS toe. [Additional Reference(s): USACE Sacramento O&M Manual 104, February 1960, (RM 21.97), 10-inch pipe referenced]. FS Date: 2/13/2014 | | | | | |

Pump and tank in box on LS shoulder.

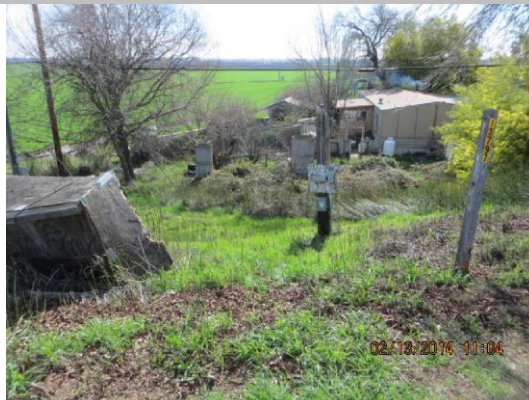
Photo 2 of 3 : UCIP_SP_2018_31584_57842.jpg

Pump and tank in box on LS shoulder with concrete standpipe visible on LS toe.

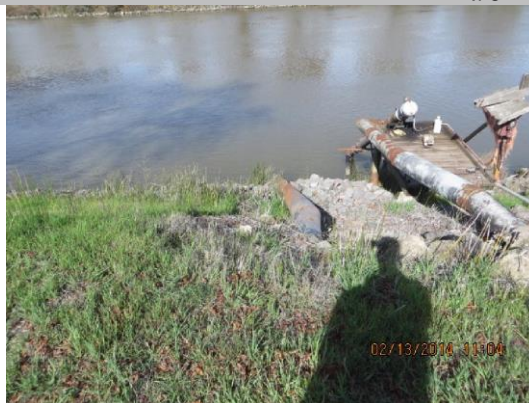
Photo 3 of 3 : UCIP_SP_2018_31584_57844.jpg

| FS_ID:31584 DS_ID:22158 EP_NO: N/A Repair Type: Non-Urgent Crossing Status: Found UCIP Comments: Appears abandoned and if so should be done so properly. FIELD_STRUCT_DESC: 12-inch steel irrigation siphon through the levee, invert elevation 2.7 feet below the crown. Pump and tank visible in a box on the landside (LS) shoulder. Electrical panel on the LS slope with a concrete standpipe at the LS toe. [Additional Reference(s): USACE Sacramento O&M Manual 104, February 1960, (RM 21.97), 10-inch pipe referenced]. FS Date: 2/13/2014 | | | | | |

Pipe visible on WS slope.

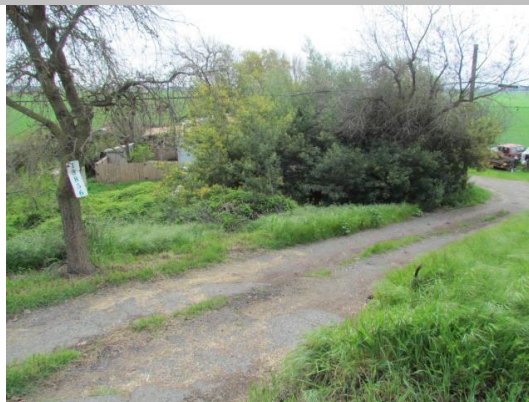
Photo 1 of 1 : SP_2018_RD0003_24_71_20180305_00059.jpg

| Dense trees blocking view of landward toe. | | | | | |

Looking east at dense vegetatin next to ramp on landward slope.

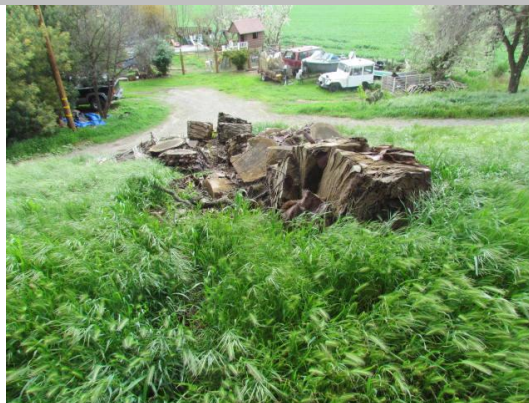
Photo 1 of 1 : SP_2018_RD0003_24_77_20180305_00068.jpg

| Landowner storing tree stumps on landward slope. | | | | | |

Looking east at stumps on landward slope.

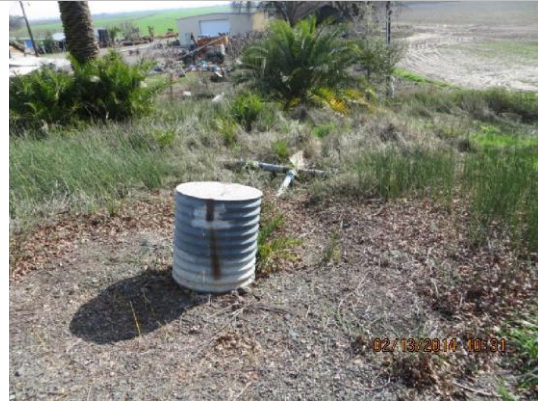
Photo 2 of 3 : UCIP_SP_2018_52541_54545.jpg

FS_ID:52541
DS_ID:22163
EP_NO: N/A
Repair Type: Urgent
Crossing Status: Found
UCIP Comments: 09/29/2017 Received updated photo from DWR levee inspector, D. Torres, and photo shows part or all of the pipe has been removed. Inspector could not verify proper abandonment. Need to coordinate with LMA and owner to determine supporting documentation to support the work completed at this site. This crossing remains urgent due to the details of the extent of the removal. No permit was found to authorizing levee work. (DWR UCIP - O. Magana) 07/06/2016 Pipe diversion off main steam on LS has tape wrapped around its connections, a possible attempt to contain past leakage. Did not see active leakage. Slight sloughing on LS slope at diversion manifold. (DWR UCIP - kfazel)02/13/2014 Pipe disconnected or diverted on LS shoulder and leaking. Water runs down LS slope freely causing erosion. Siphon breaker not visible in CMP riser. Walkway to pump in poor structural condition. (DWR UCIP - pamatya)

24-inch CMP riser for siphon breaker on LS shoulder.

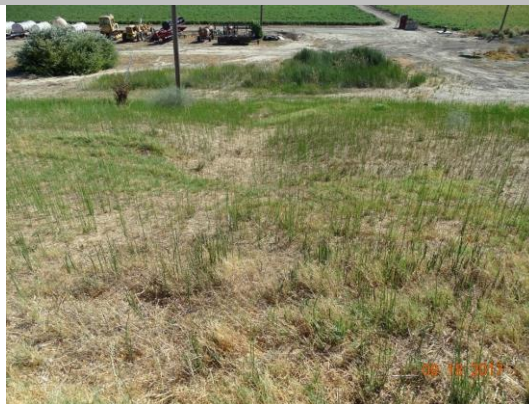
Photo 1 of 1 : SP_2018_RD0003_24_83_20180305_00075.jpg

| Landside slope has a depression. | | | | | |

Looking east on landside slope.

| S1 : Repair slope instability. | | | | | |

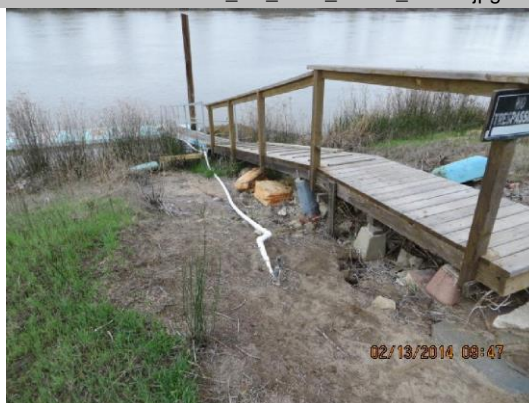
Photo 1 of 3 : UCIP_SP_2018_31286_57295.jpg

| FS_ID:31286 DS_ID:24837 EP_NO: N/A Repair Type: Non-Urgent Crossing Status: Found UCIP Comments: No permit identified for this crossing. FIELD_STRUCT_DESC: 1.5-inch polyvinyl chloride (PVC) irrigation pipe through the levee, 2 feet below the crown. Pump at the landside (LS) toe. Vent on the waterside (WS) shoulder. This crossing was field discovered. FS Date: 2/13/2014 | | | | | | |

Pipe and vent visible next to wooden walkway on WS shoulder.

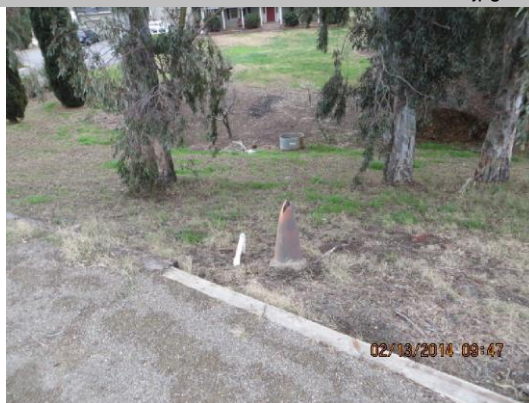
Photo 2 of 3 : UCIP_SP_2018_31286_57294.jpg

Pipe visible on LS shoulder with pump visible at LS toe in background.

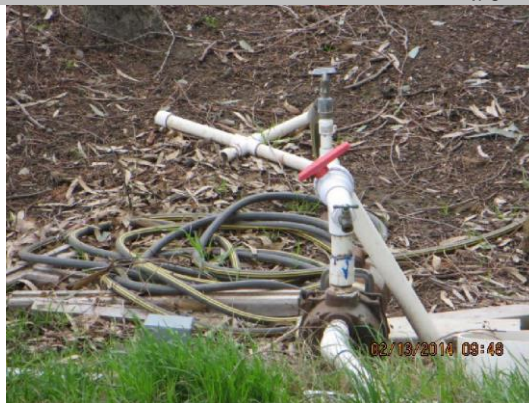
Photo 3 of 3 : UCIP_SP_2018_31286_57293.jpg

| FS_ID:31286 DS_ID:24837 EP_NO: N/A Repair Type: Non-Urgent Crossing Status: Found UCIP Comments: No permit identified for this crossing. FIELD_STRUCT_DESC: 1.5-inch polyvinyl chloride (PVC) irrigation pipe through the levee, 2 feet below the crown. Pump at the landside (LS) toe. Vent on the waterside (WS) shoulder. This crossing was field discovered. FS Date: 2/13/2014 | | | | | | |

Pump and shutoff valve visible at LS toe.

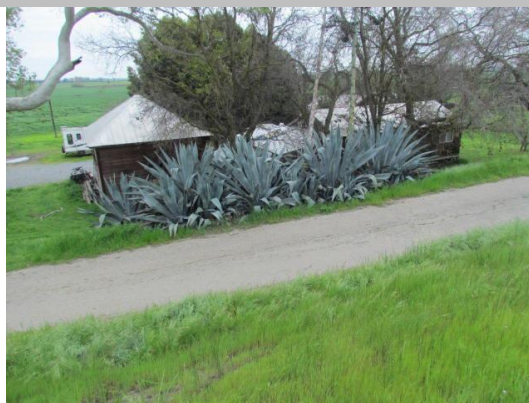
Photo 1 of 2 : SP_2018_RD0003_24_79_20180305_00071.jpg

| Large century plants blocking view of landward slope. | | | | | |

Looking at century plants on landward slope and toe.

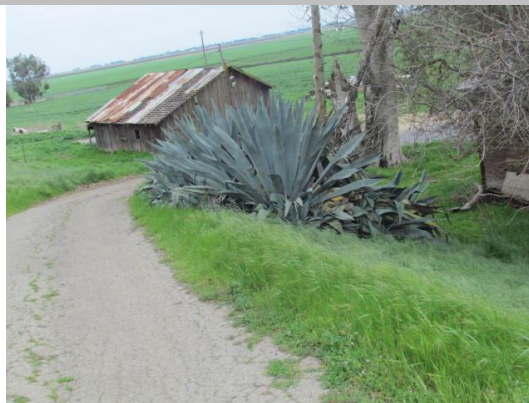
Photo 2 of 2 : SP_2018_RD0003_24_79_20180305_00072.jpg

| Large century plants blocking view of landward slope. | | | | | | |

Looking at century plants on landward slope and toe.

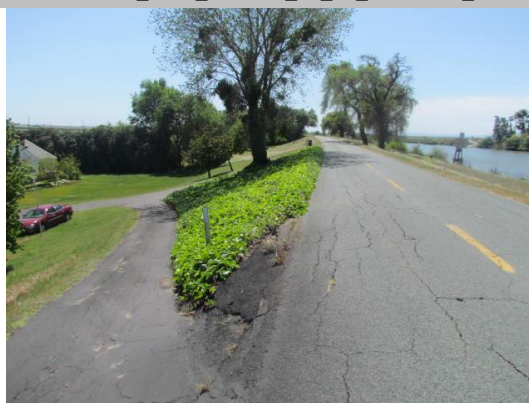
Photo 1 of 1 : SP_2018_RD0003_24_43_20180305_00034.jpg

Looking southeast at ground cover on landward slope.

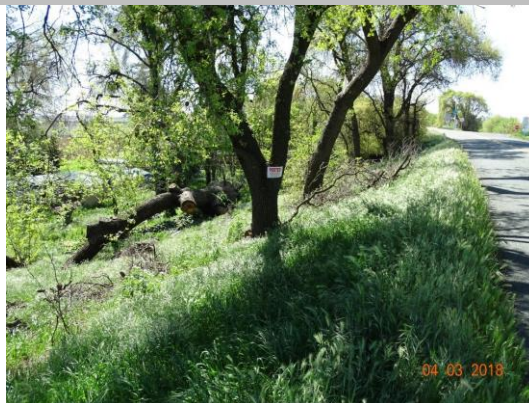
Photo 1 of 1 : SP_2018_RD0003_24_58_20180403_00177.jpg

| Downed tree with large root ball on landward slope is being cut up and should be removed. | | | | | |

Removal of large fallen tree should continue.

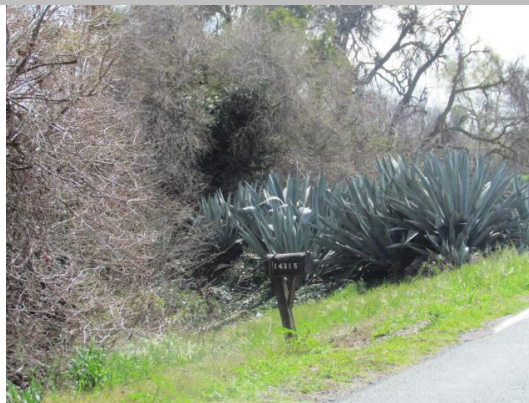
Photo 1 of 1 : SP_2018_RD0003_24_44_20180305_00035.jpg

| Large century plants. | | | | | |

Looking southeast at century plants on landside shoulder and slope.

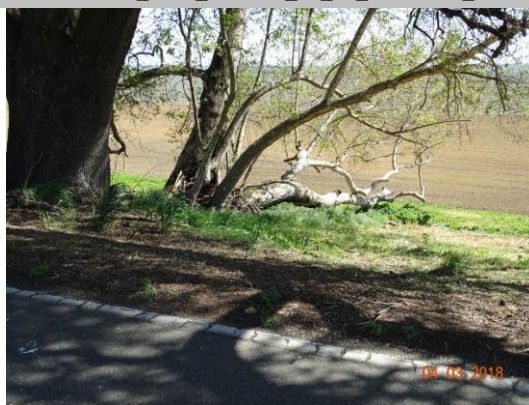
Photo 1 of 1 : SP_2018_RD0003_24_63_20180403_00178.jpg

| Large tree limb lays just above surface of landside slope and prevents inspection and access to slope beneath it. It should be removed. | | | | | |

Low-lying tree limb should be removed from landside slope.

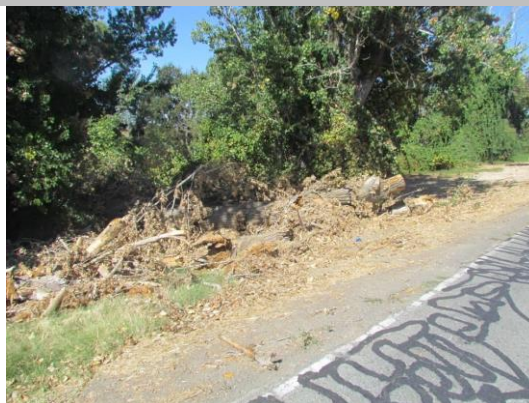
Photo 1 of 1 : SP_2018_RD0003_24_66_20180305_00055.jpg

| Broken tree branches and limbs on waterward slope. | | | | | |

Looking west at tree branches and limbs on waterward slope.

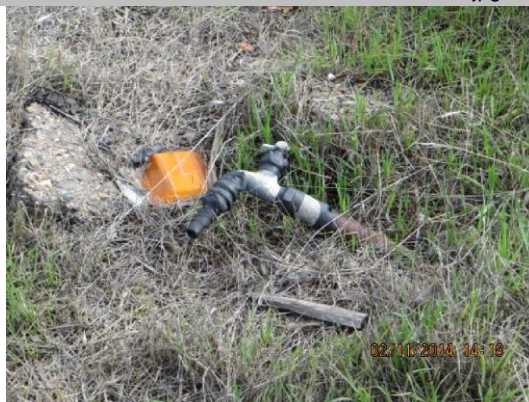
Photo 2 of 3 : UCIP_SP_2018_29823_55104.jpg

Vent on LS shoulder.

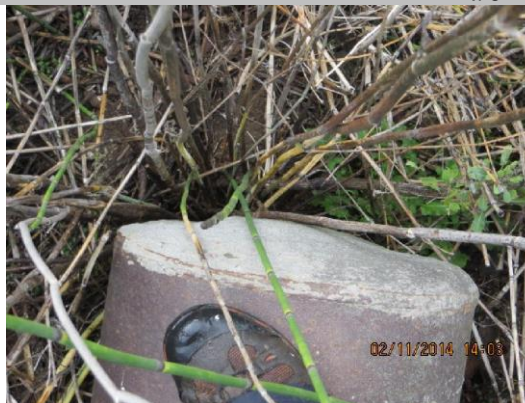
Photo 2 of 3 : UCIP_SP_2018_29403_54461.jpg

| FS_ID:29403 DS_ID:22173 EP_NO: 1392 Repair Type: Non-Urgent Crossing Status: Found UCIP Comments: Pipe abandoned and should be done so properly. FIELD_STRUCT_DESC: *ABANDONED* 18-inch steel irrigation discharge pipe through the levee, invert elevation 4.5 feet below the crown. Pump removed from the pile structure in the slough. Concrete standpipe on the landside (LS) toe. Concrete plug on the waterside (WS) end. (Plans for installing a vertical unit irrigation pumping plant with an 18-inch steel pipe through the levee authorized under Permit No. 1392, 1949 - Ednora Stefani). [Additional Reference(s): DWR Levee Log, 1993. USACE Sacramento O&M Manual 104, February 1960, (RM 19.83)]. FS Date: 2/11/2014 | | | | | |

Concrete plug in abandoned pipe on WS slope.

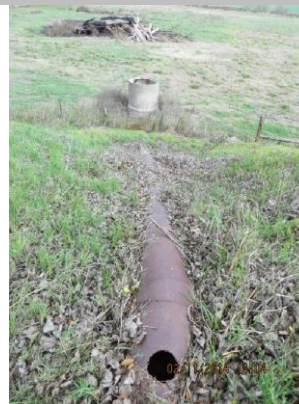
Photo 3 of 3 : UCIP_SP_2018_29403_54460.jpg

Pipe and concrete standpipe on LS slope.

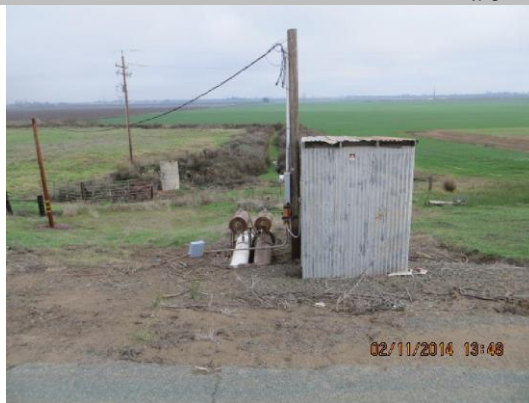
Photo 1 of 3 : UCIP_SP_2018_29266_54159.jpg

| FS_ID:29266 DS_ID:22175 EP_NO: N/A Repair Type: Non-Urgent Crossing Status: Found UCIP Comments: Hole in pipe on WS slope may need to be sealed depending on nature of sliplined pipe. FIELD_STRUCT_DESC: 1 of 2: 18-inch steel irrigation siphon through the levee, invert elevation 7 feet below the crown. Primer pump in a pump house on the landside (LS) slope. Pipe has been slip lined with a high-density polyethylene (HDPE) liner. Polyvinyl chloride (PVC) pipe may be attached to the steel pipe on the LS shoulder. [Additional Reference(s): DWR Levee Log, 1993. USACE Sacramento O&M Manual 104, February 1960, (RM 19.77)]. FS Date: 2/11/2014 | | | | | | |

Pipe visible next to pumphouse on LS shoulder.

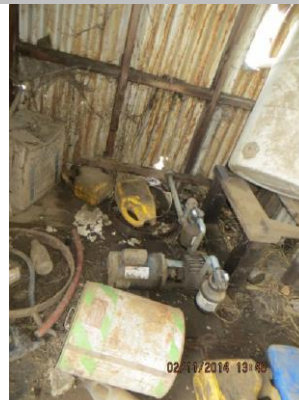
Photo 2 of 3 : UCIP_SP_2018_29266_54158.jpg

Pump in pumphouse on LS shoulder.

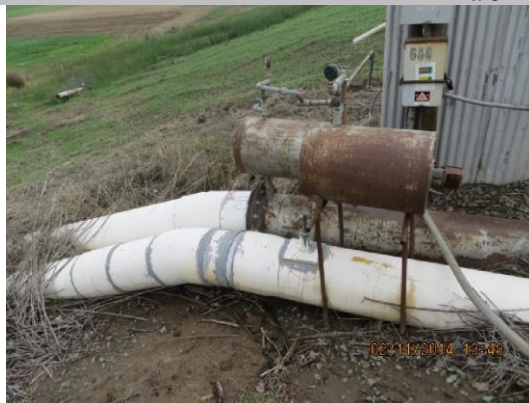
Photo 3 of 3 : UCIP_SP_2018_29266_54157.jpg

| FS_ID:29266 DS_ID:22175 EP_NO: N/A Repair Type: Non-Urgent Crossing Status: Found UCIP Comments: Hole in pipe on WS slope may need to be sealed depending on nature of sliplined pipe. FIELD_STRUCT_DESC: 1 of 2: 18-inch steel irrigation siphon through the levee, invert elevation 7 feet below the crown. Primer pump in a pump house on the landside (LS) slope. Pipe has been slip lined with a high-density polyethylene (HDPE) liner. Polyvinyl chloride (PVC) pipe may be attached to the steel pipe on the LS shoulder. [Additional Reference(s): DWR Levee Log, 1993. USACE Sacramento O&M Manual 104, February 1960, (RM 19.77)]. FS Date: 2/11/2014 | | | | | | |

PVC pipe at LS shoulder.

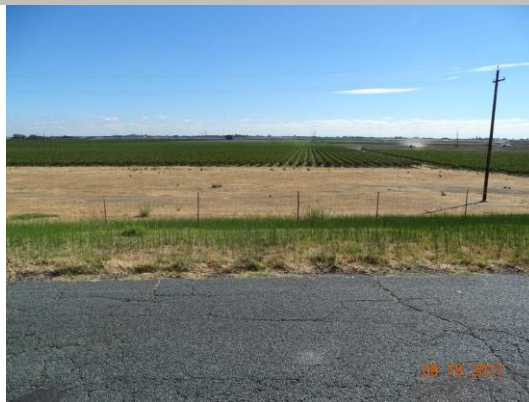
Photo 1 of 1 : SP_2018_RD0003_24_84_20180305_00076.jpg

| Fence on landside slope. | | | | | |

Looking east at fence at landside toe.

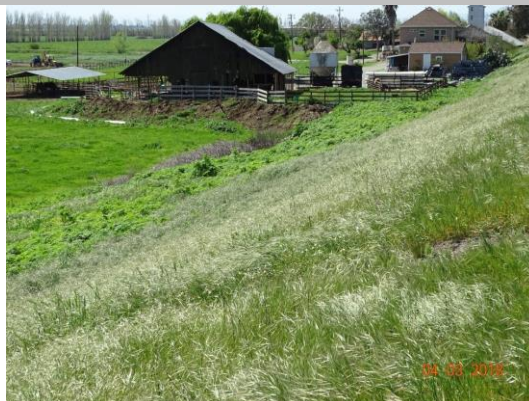
Photo 1 of 1 : SP_2018_RD0003_24_86_20180403_00179.jpg

| Dense vegetation along landside toe. | | | | | |

Dense vegetation along landside toe prevents inspection and access.

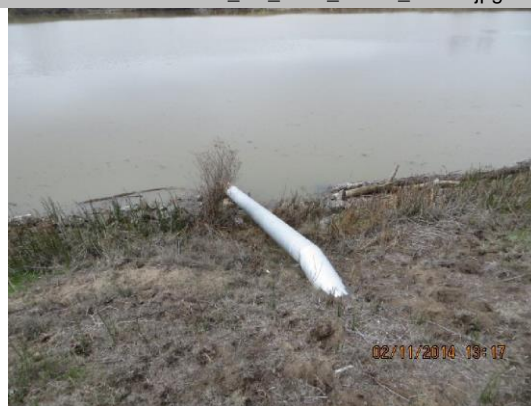
Photo 1 of 3 : UCIP_SP_2018_29258_54138.jpg

| FS_ID:29258 DS_ID:22179 EP_NO: 853 Repair Type: Non-Urgent Crossing Status: Found UCIP Comments: Siphon breaker/vent needs proper installation/riser. FIELD_STRUCT_DESC: 12-inch steel irrigation siphon through the levee, invert elevation 4 feet below the crown. Siphon breaker on the landside (LS) shoulder. 36-inch concrete standpipe on the LS toe. (Plans for the installation of a 6-inch horizontal bolted centrifugal pump together with an 8-inch, 10-gauge welded steel pipe through the levee authorized under Permit No. 853, 1941 - Louis A. Bixler. Plans for installing a 12-inch steel irrigation siphon through the levee authorized under Permit No. 1462, 1950 - Vic Romanini. USACE Unit No. 10, new pipe installed in 1967). [Additional Reference(s): DWR Levee Log, 1993. USACE Sacramento O&M Manual 104, February 1960, (RM 19.20)]. FS Date: 2/11/2014 | | | | | |

Pipe visible on WS slope.

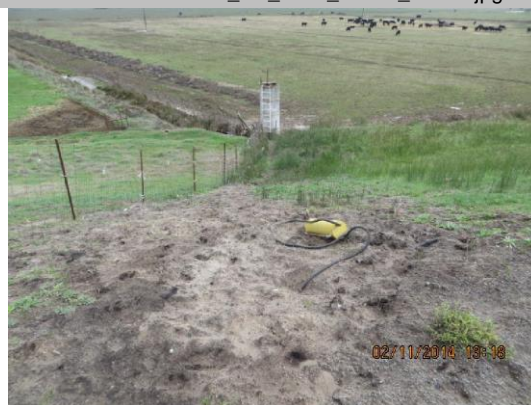
Photo 2 of 3 : UCIP_SP_2018_29258_54137.jpg

Siphon breaker/vent visible on LS slope with concrete standpipe visible in background at toe.

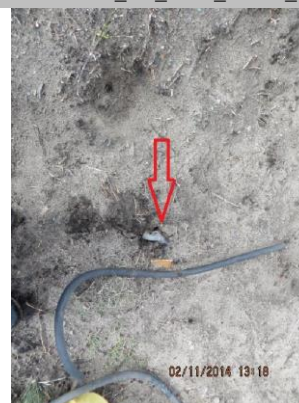
Photo 3 of 3 : UCIP_SP_2018_29258_54136.jpg

| FS_ID:29258 DS_ID:22179 EP_NO: 853 Repair Type: Non-Urgent Crossing Status: Found UCIP Comments: Siphon breaker/vent needs proper installation/riser. FIELD_STRUCT_DESC: 12-inch steel irrigation siphon through the levee, invert elevation 4 feet below the crown. Siphon breaker on the landside (LS) shoulder. 36-inch concrete standpipe on the LS toe. (Plans for the installation of a 6-inch horizontal bolted centrifugal pump together with an 8-inch, 10-gauge welded steel pipe through the levee authorized under Permit No. 853, 1941 - Louis A. Bixler. Plans for installing a 12-inch steel irrigation siphon through the levee authorized under Permit No. 1462, 1950 - Vic Romanini. USACE Unit No. 10, new pipe installed in 1967). [Additional Reference(s): DWR Levee Log, 1993. USACE Sacramento O&M Manual 104, February 1960, (RM 19.20)]. FS Date: 2/11/2014 | | | | | |

Siphon breaker/vent visible on LS slope.

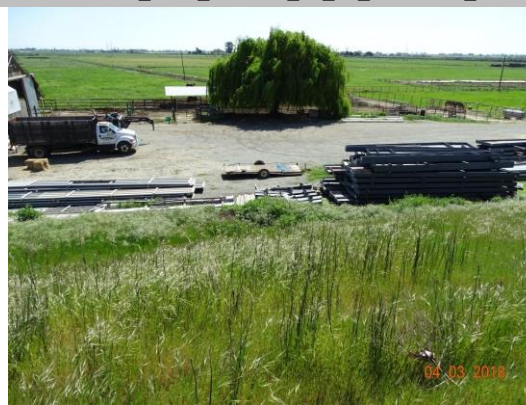
Photo 1 of 1 : SP_2018_RD0003_24_87_20180403_00180.jpg

Equipment stockpiled at landside toe.
